1
NASA Technical Memorandum 78912

Application of Multispectral Scanner Data to the Study of an Abandoned Surface Coal Mine

Ernie W. Spisz

NOVEMBER 1978

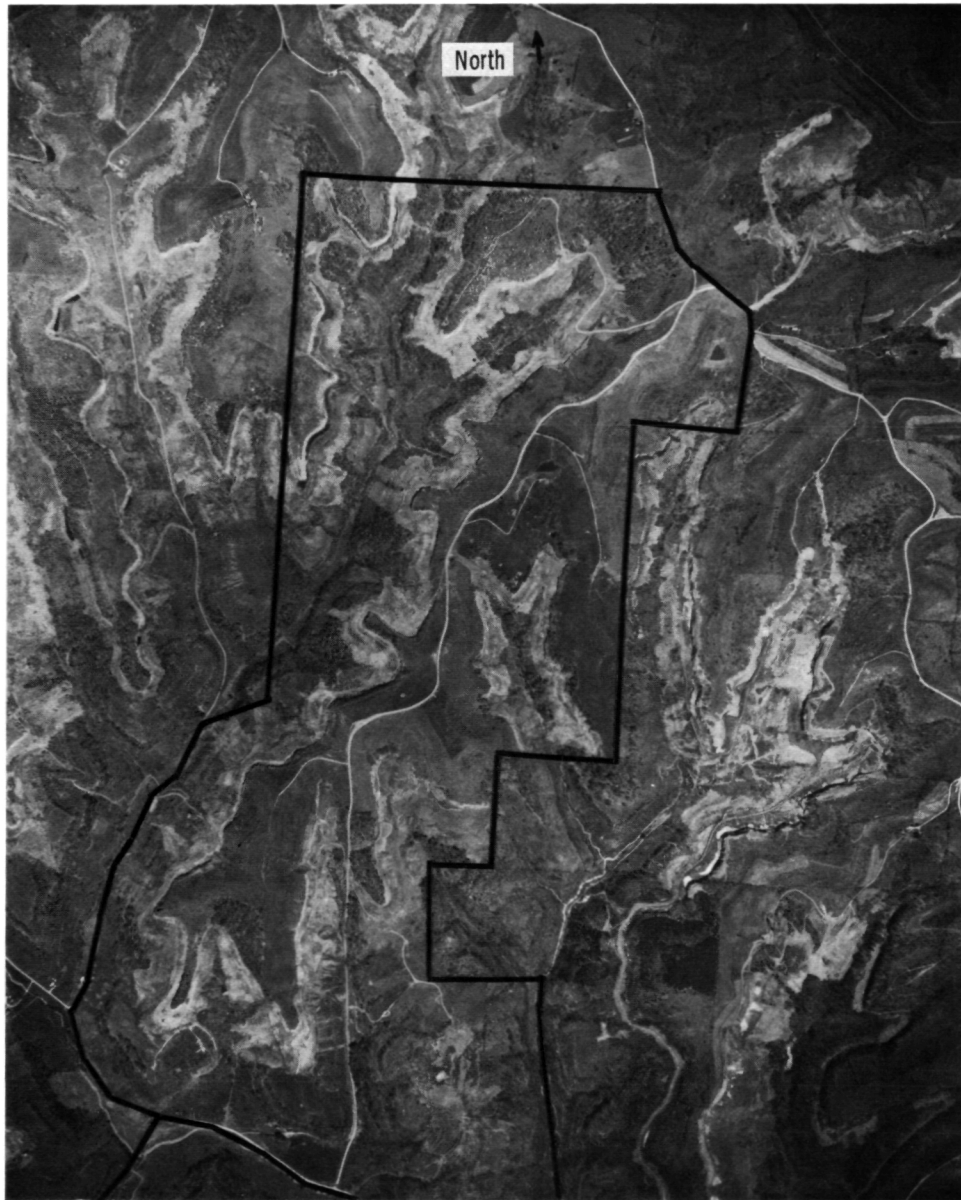
Figure 2. - Aerial photograph of EORDC strip-mine test site. Scale, 24 000.

A black-and-white aerial photograph of the EORDC test site at a scale factor of 24 000 is shown in figure 2 with the property boundary outlined. The test site is approximately 1.6 kilometers wide and 3.5 kilometers long and comprises 6 000 000 square meters. The site was contour- and auger-mined and contains approximately 13 kilometers of winding strip-mined bench areas and 1.6 million square meters of exposed, sterile spoil material. The spoil material is primarily sandstone and shale and is extremely toxic, with soil pH values ranging primarily from 2.5 to 4.5. The bench areas are from 15 to 90 meters wide and the highwalls are from 6 to 15 meters high. The spoilbanks are very rocky to stony, with slopes ranging from moderate to very steep. There are four deep, freshwater ponds in the area that are used for cattle watering and numerous, shallow, highly acidic impounded-water areas along the highwalls. The drainage streams for the area are also polluted, with pH values ranging from 3.5 to 4.5.

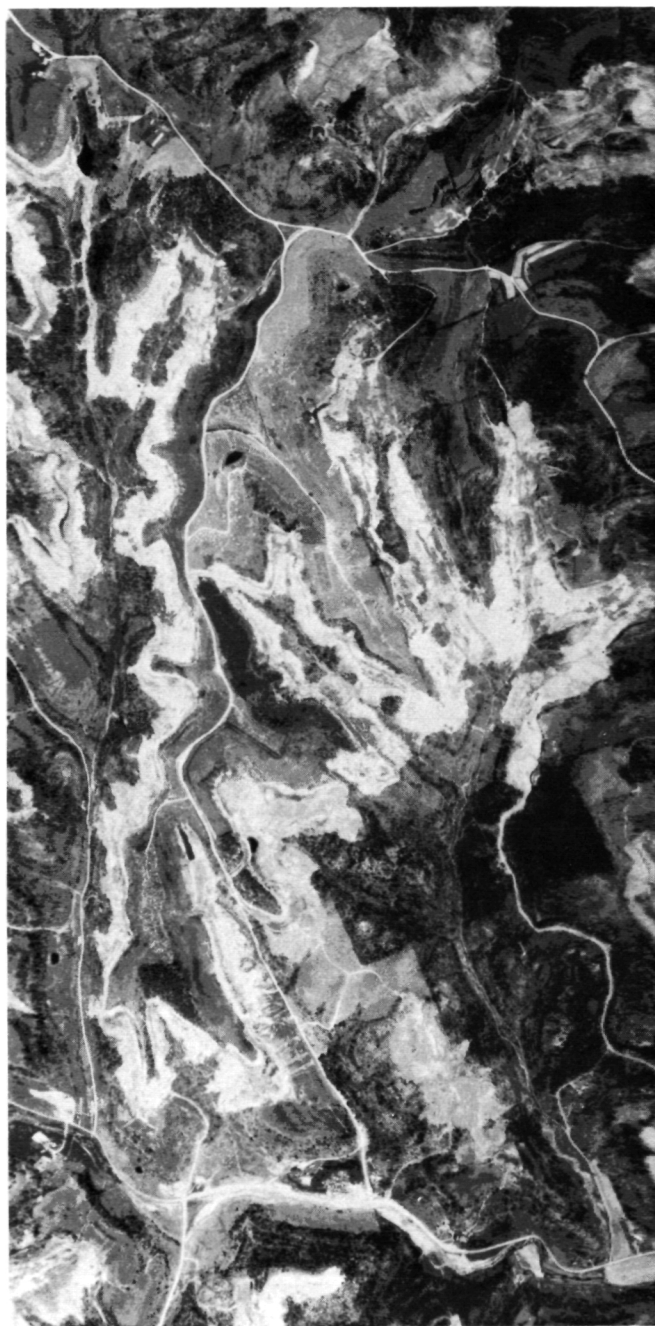
Figure 4. - Multispectral scanner image. May 1976; channel 7;
altitude, 1.2 kilometers.

Figure 4 is a typical single-channel computer image of the test area that was produced from scanner data obtained at an aircraft altitude of 1.2 kilometers. The image was produced from channel 7 data (center wavelength, $0.68 \mu\text{m}$) and resembles somewhat a panchromatic photograph (fig. 2). The image contains the entire scene of one complete CCT and consists of approximately 2200 scan lines of data. The scale factor of the figure 4 image is 24 000, and it is a 2.5-times enlargement of the original negative generated by the Optronics film recorder. The Optronics image is constructed point by point, has been rectified (i. e., corrected for scanner "look angle" distortions) by point replication, and can be compared reasonably well with an aerial photograph or a topographic map. (See appendix F for discussion of image rectification.) The image rectification, however, is only approximate because of topography and aircraft motion, and an accurate overlay between the image and a map cannot be obtained over the entire image area.

With experience, conventional photointerpretive techniques can be used to qualitatively evaluate the single-channel image. In figure 4, the barren areas and haul roads

are white to light gray, the undisturbed pasture and agricultural areas are light to medium gray, and the forested areas are dark gray for hardwoods to black for evergreens. The surface-water areas range from light gray to black. Similar black-and-white images can be generated for all 11 scanner channels.

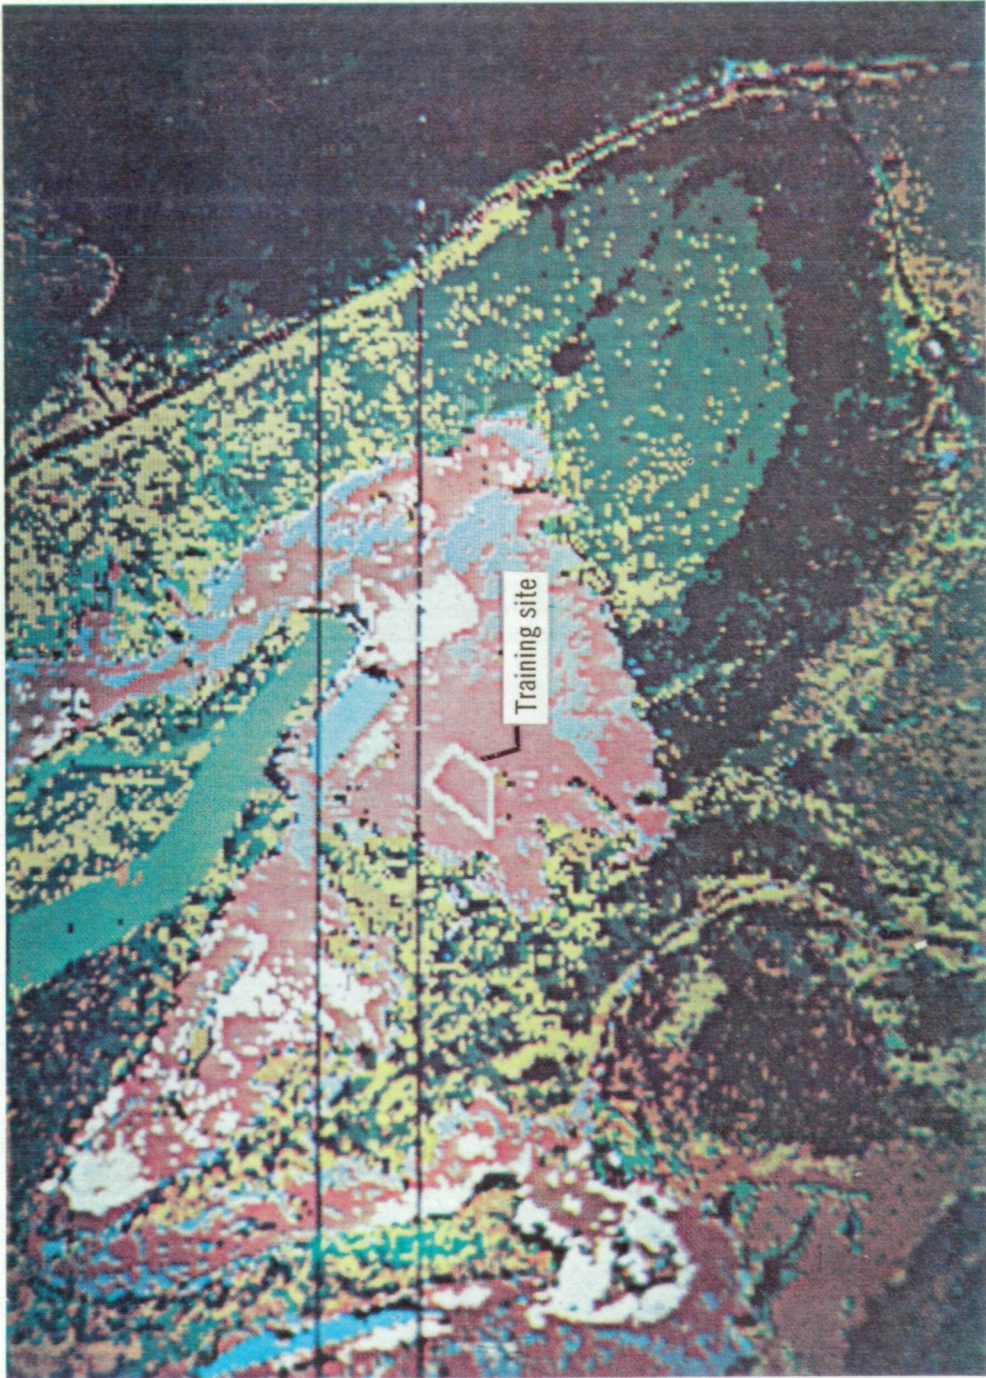
Figure 5. - Typical training site. (Cursor superimposed over final color classification.)

A typical cursor outline to describe a training site is shown in figure 5. The image was photographed directly from the MDAS video display with a 35-millimeter camera. The cursor location is shown for the sandstone-spoilbank training site (SP1c) of appendix A and is displayed over the final classification of the data in figure 5. The figure illustrates the detail of the MDAS display, the relative homogeneity of the data within the cursor (training-site data) as required for good training-site selection, and the varied color classification that can occur near a training site. The pixel-by-pixel quality of the display is evident in the photograph.

Generally, training sites consist of 100 to 300 pixels for undisturbed vegetated areas, 50 to 150 pixels for barren areas, and 10 to 50 pixels for water areas. Training sites of this size are adequate to obtain a valid statistical sample. However, the training-site location must be established with extreme care, especially for the complex barren land areas, where graded and ungraded areas can be in close proximity or where sparsely revegetated areas and barren areas are indistinguishable. For this study, training sites were selected from a single-channel, color-density slice or a three-channel, superposition, false-color display. A single channel or the combination of three channels could not be used for the selection of all the training sites. A variety of data channels was required throughout the training-site selection process to insure the accuracy of the data.

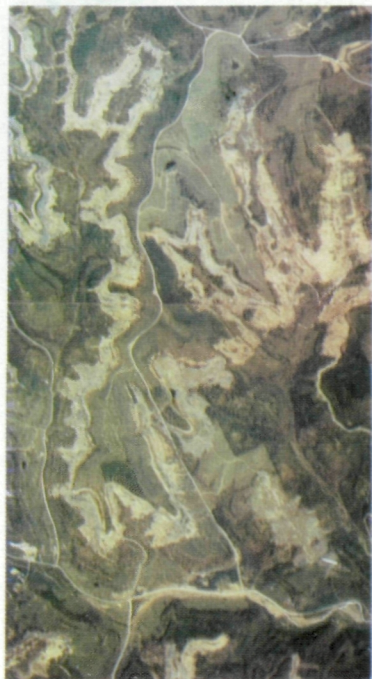
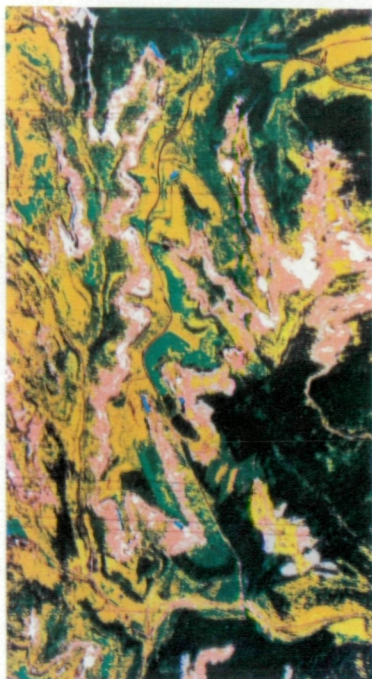
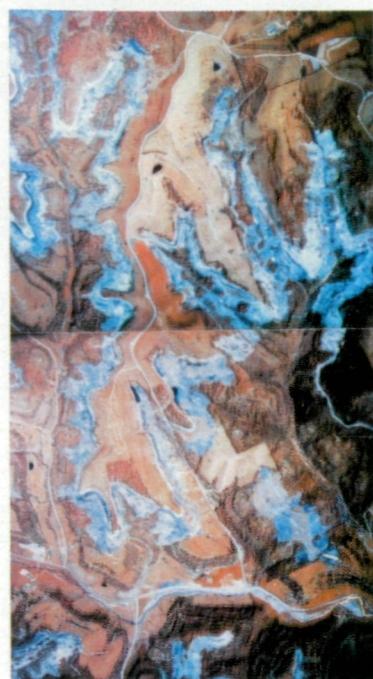
(a) Comparison of computer-classified color image and aerial photographs. Scale factor, 36 000.

Figure 6. - Computer-classified color image and aerial photographs of test site - September land-cover classification.

Figure 6(a) compares a typical Optronics color-coded classified image of the data contained on a complete data tape with aerial photographs of the area. The image has been geometrically rectified by point replication and is presented at a scale factor of approximately 36 000, which is a 1.7-times enlargement of the original Optronics image. Figure 6(b) is a 5-times enlargement (12 000 scale factor) of the southern part of the image and can be more readily compared with the aerial photograph of the area presented in figure 7. A scale factor of 12 000 is the most suitable scale for the general review of the image products for various mine features.

An attempt has been made to use approximately true-color coding of the classified image in order to maintain some correspondence with color photography. However, false-color coding is necessary to provide the contrast required to discriminate between various classes. The color coding consists of the following: green, undisturbed natural vegetation; yellow, revegetated areas; blue, water; gray, graded bench areas suitable for farming; pink, ungraded sandstone spoil areas; and dark gray or purple, graded or ungraded shale spoil areas. This color coding is maintained throughout this report with only slight modifications.

The general surface features of the strip-mined area easily discerned in the color images. The 11-color representation of the area, however, provides, at best, only an approximate description of the many varied and complex surface features. To establish the utility and limitations of the classification, we must evaluate the color-classified image in terms of the training-site selection, the grouping of training sites into classes, and the eventual combining of classes into colors. Table II and appendix A are included for this purpose.

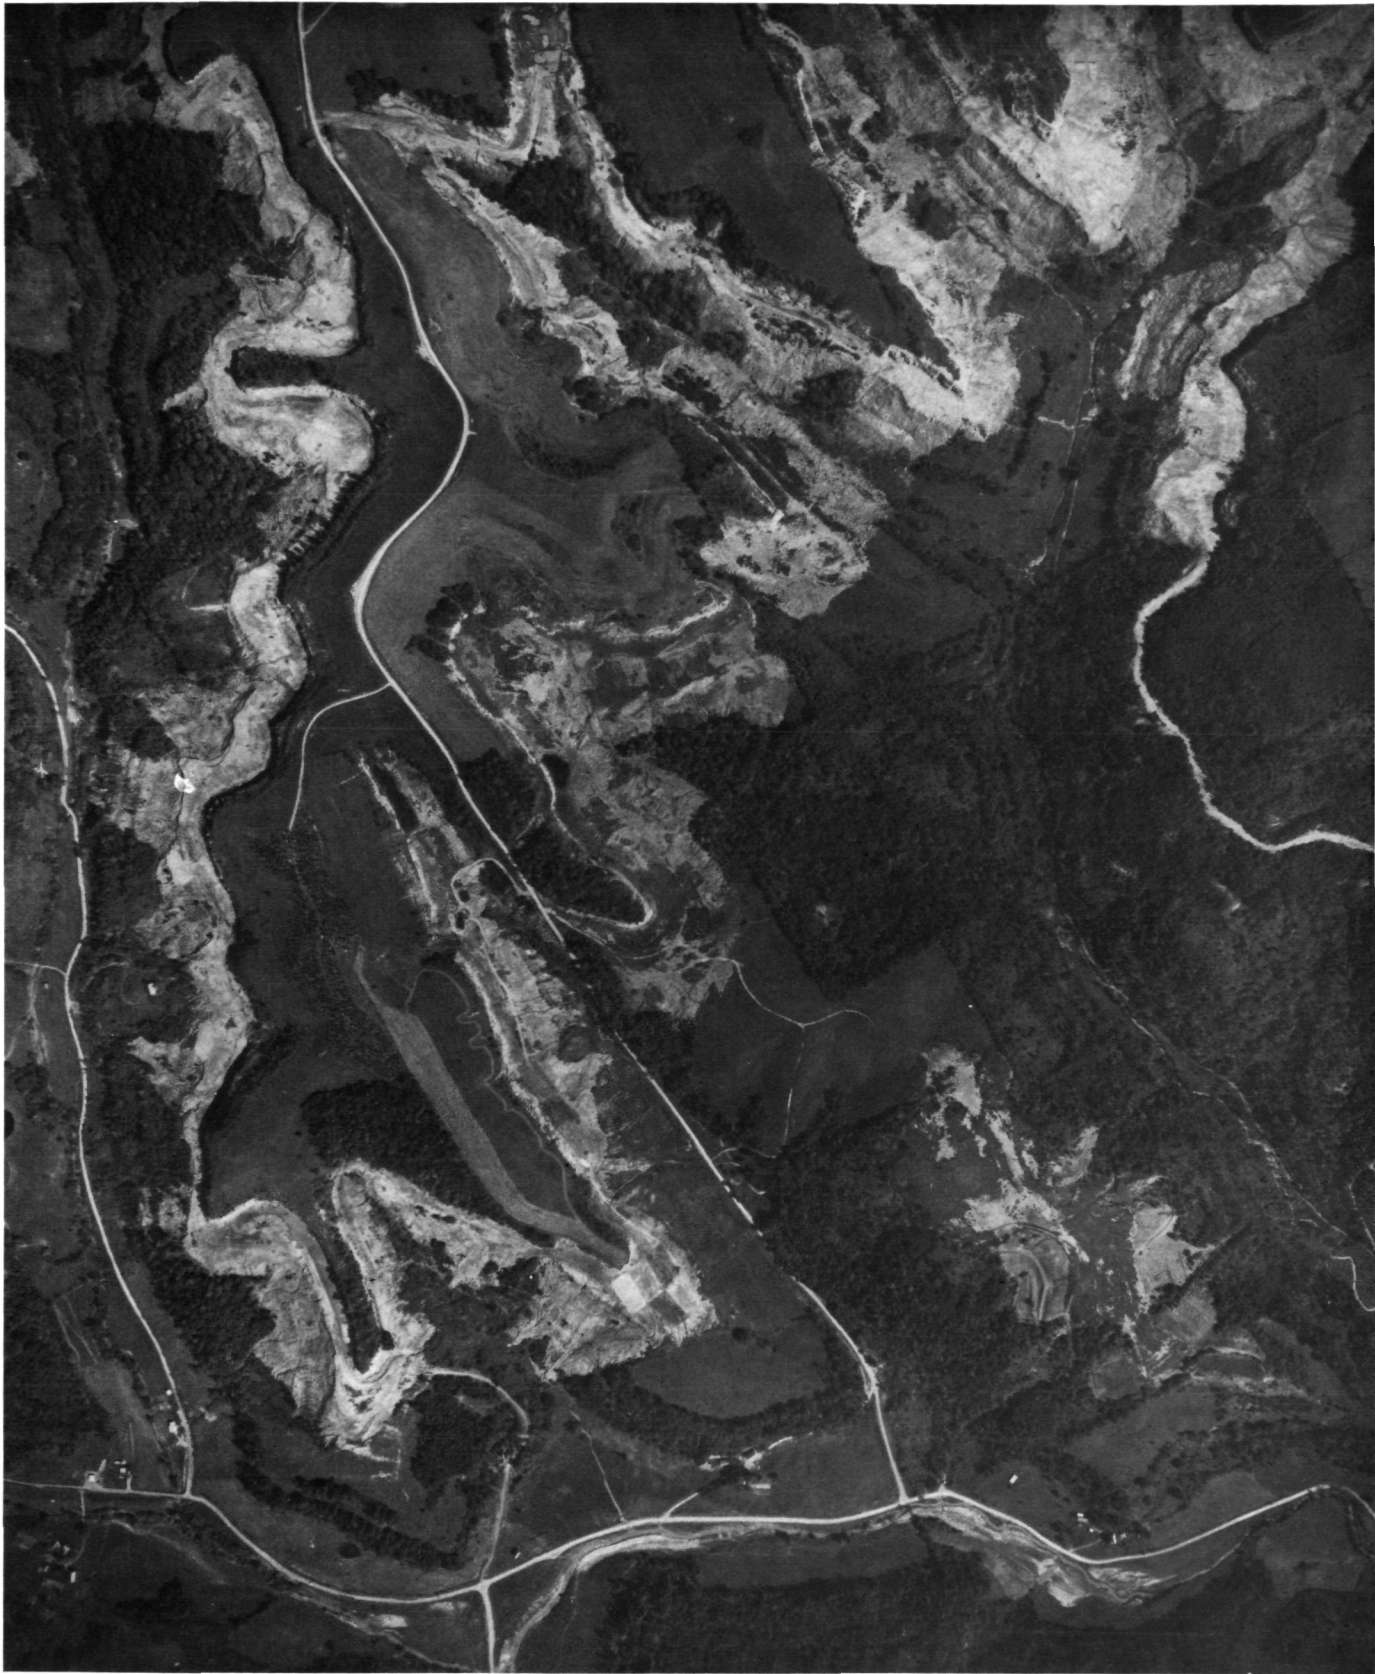
Figure 7. - Aerial photograph of southern section of test site (fig. 6(a)). Scale factor, 12 000.

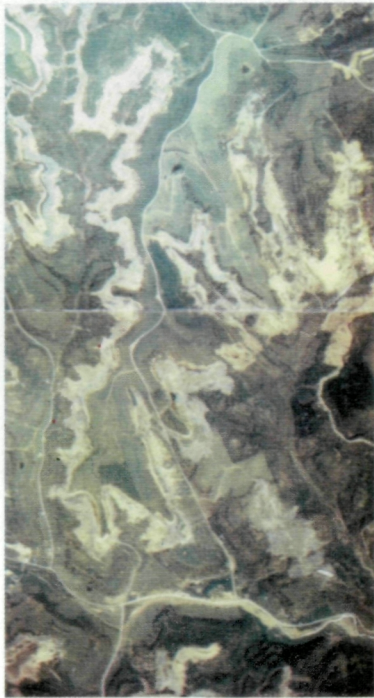
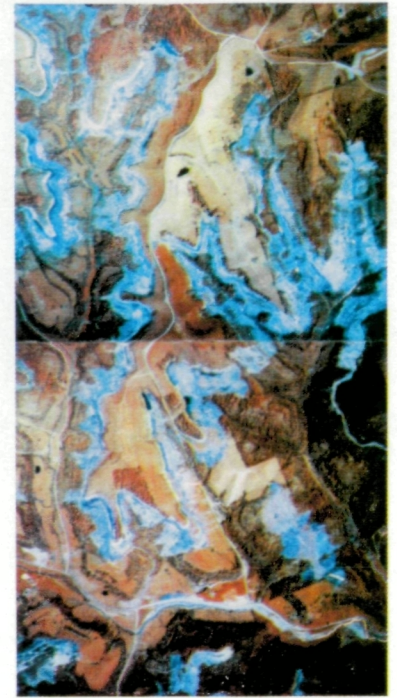
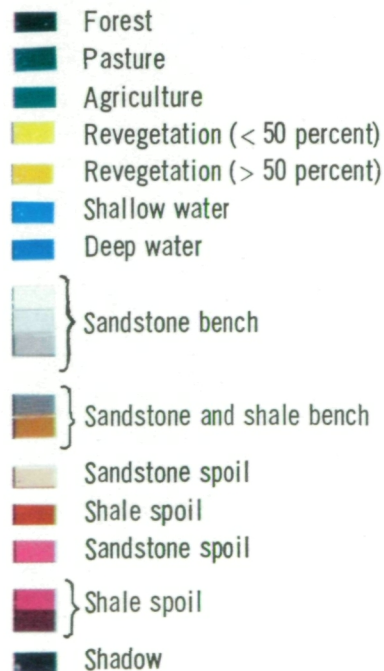
(a) Comparison of computer-classified color image and aerial photographs. Scale factor, 36 000.

Figure 9. - Computer-classified color image and aerial photographs of test site - September barren-land study.

The September data were analyzed to achieve a more detailed classification of the barren land areas. The final products of this analysis are presented in figure 9 and table III. The channel 6 and 9 representation of the class ellipses is shown in figure 10, and the radiometric and statistical data of the training sites and classes are presented in appendix B. The barren-land thematic classification of the data was more difficult and required considerably more time and effort than the general land-cover classification. For this analysis, 49 training sites, which included 18 barren land areas, were used to define 27 classes. Seventeen of the classes were barren land. A total of 18 colors were used, with 11 colors representing barren land areas. The vegetated and water areas of this classification were similar to those in the previous classification. No attempt was made to improve the classification of these areas. The vegetated classes were included in the analysis so that there would be enough classes to properly describe the area and so that the final color image could be conveniently interpreted and compared with aerial photographs or with the other classified images of the area.

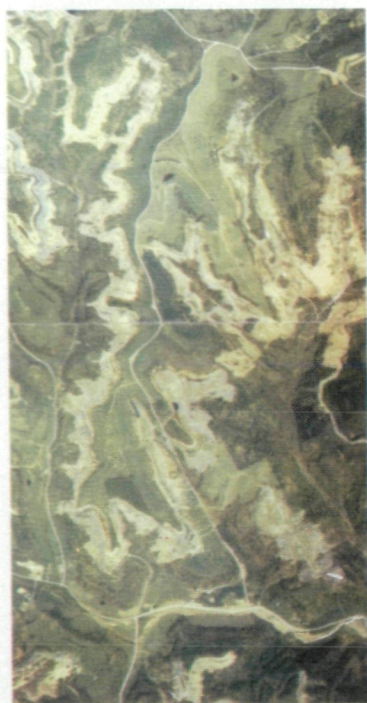
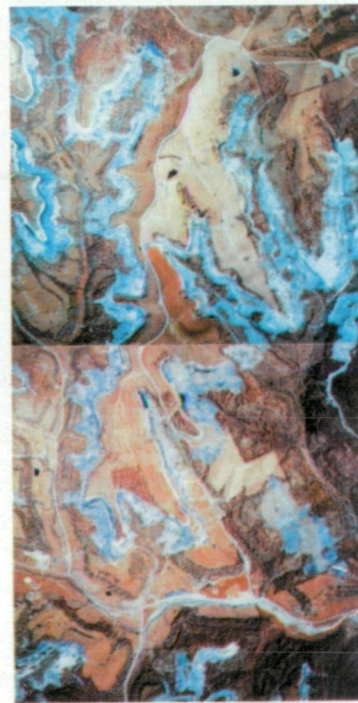
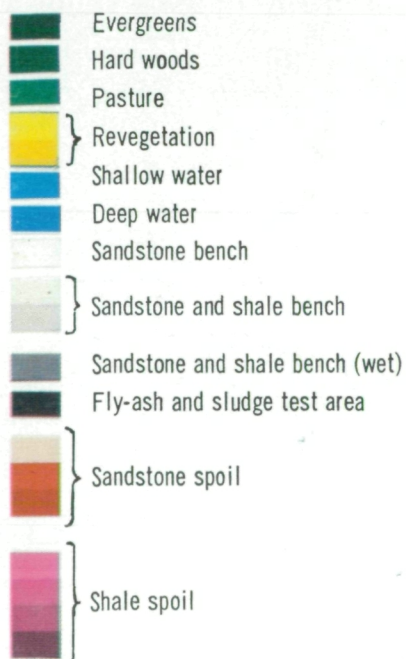
(a) Comparison of computer-classified color image and aerial photographs.

Figure 11. - Computer-classified color image and aerial photographs of test site - March barren-land study.

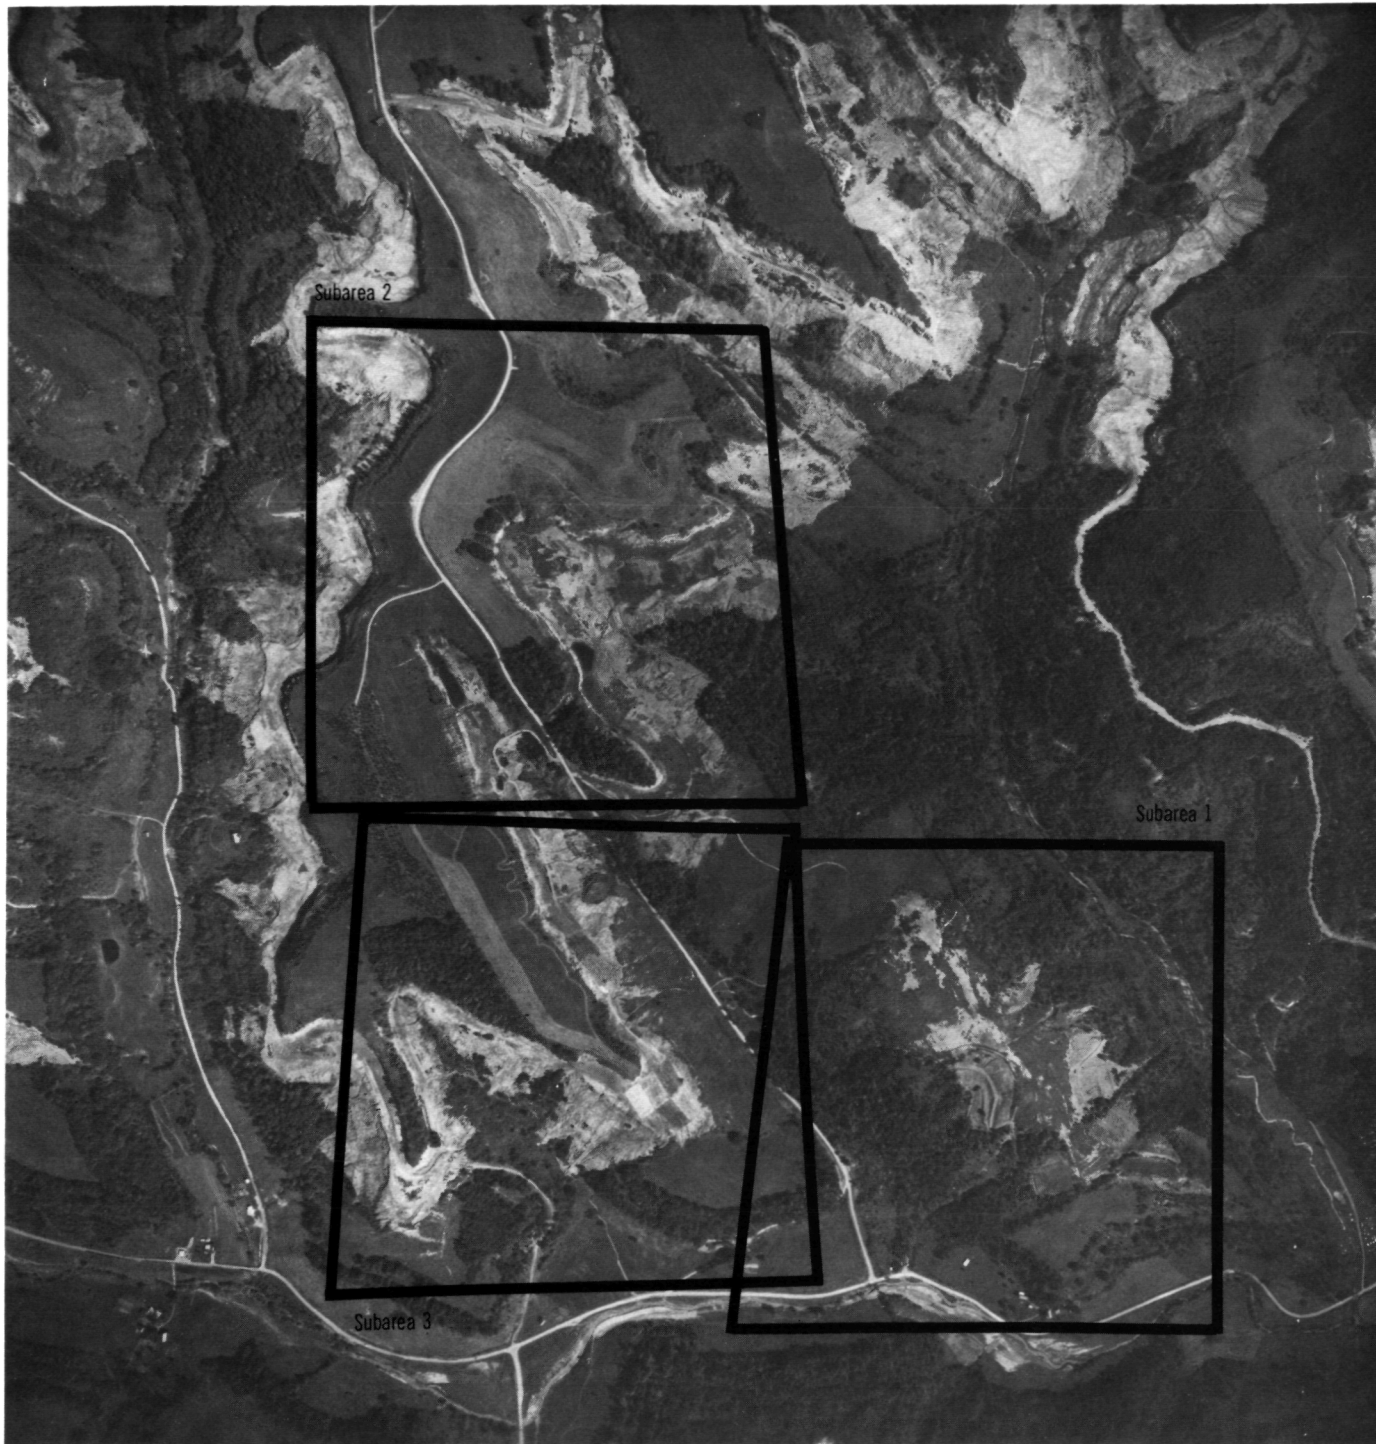
Figure 13. - Location of subareas in southern section of test site. Scale factor, 12 000.

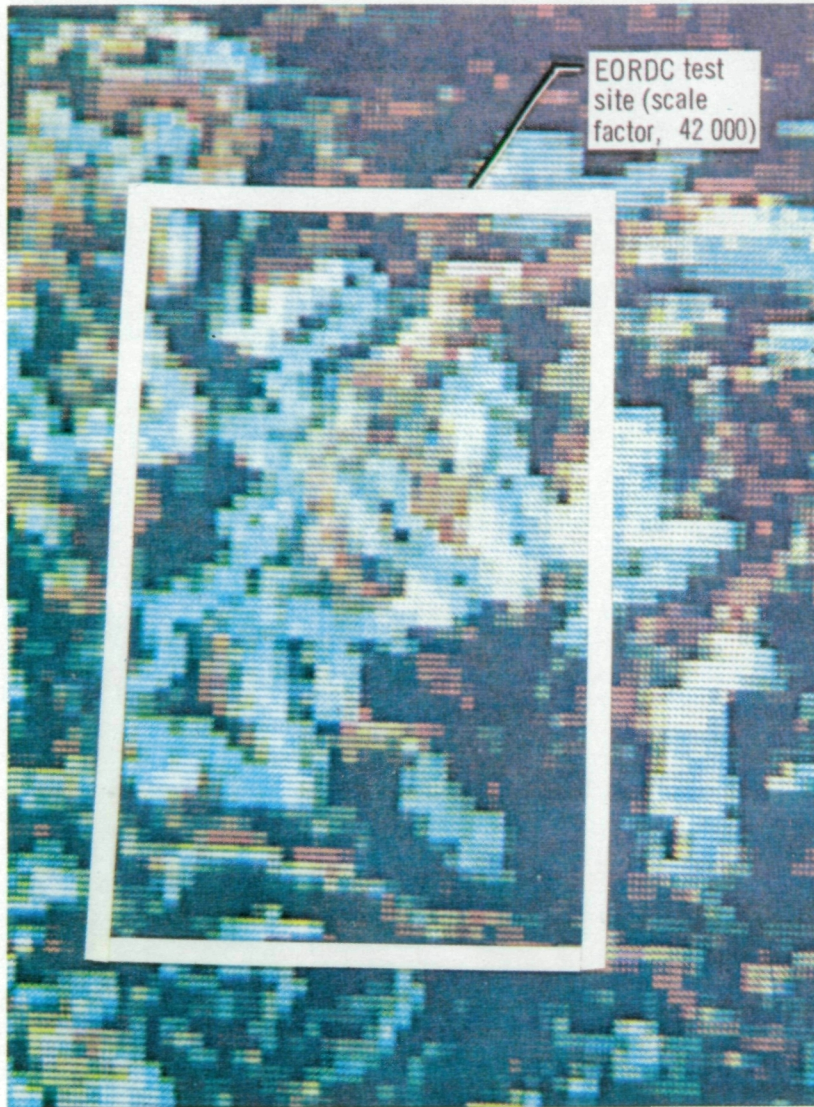
Figure 17. - Landsat view of test site (MDAS display enlarged 2 times.)

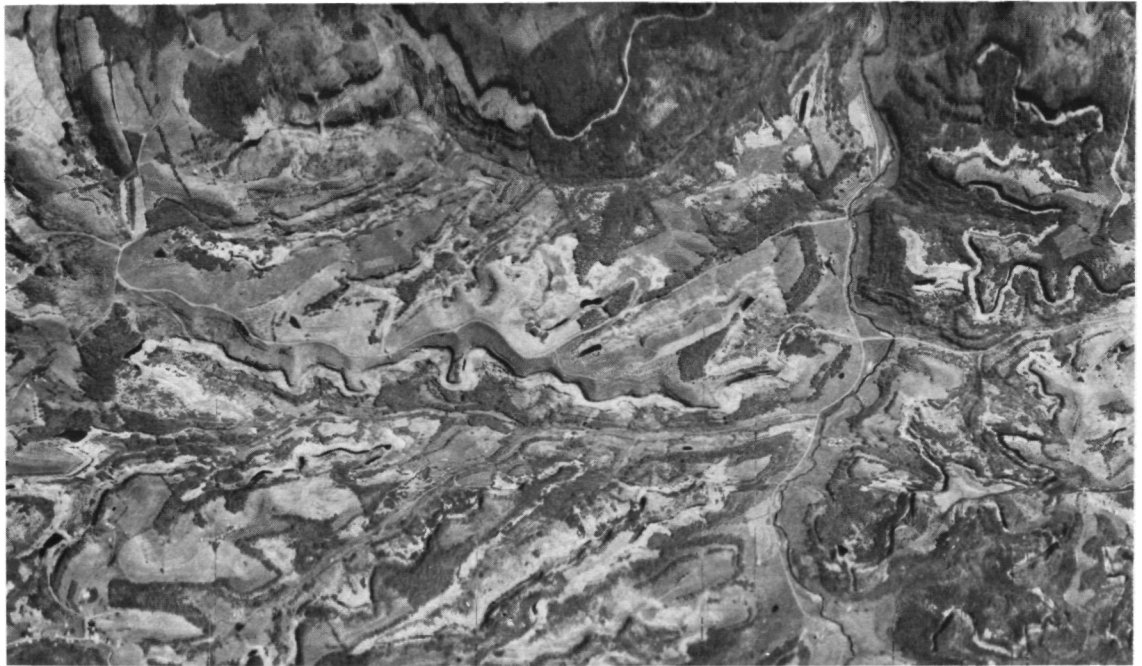
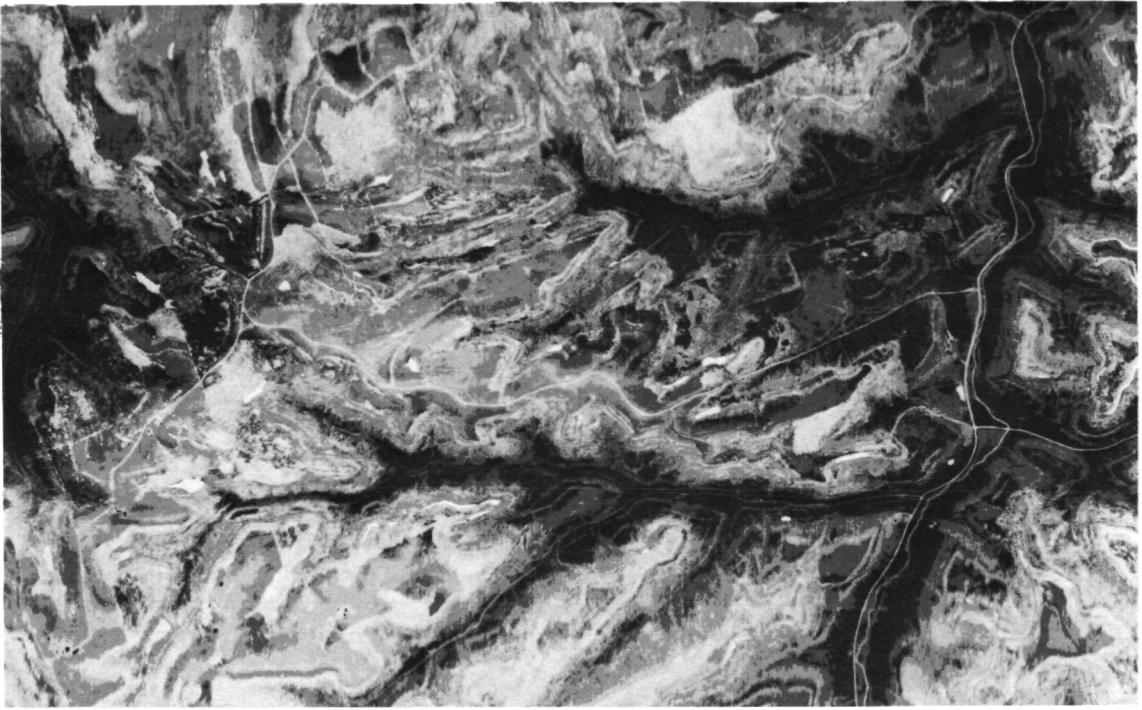
Figure 21. - Thermal images of test site. Scale factor, 24 000.

In the day thermal color image the water areas are gray (low temperatures); the black, highly absorbing, graded shale spoils are red/pink (high temperatures); and the vegetated areas are green/blue (intermediate temperatures). These generalizations are qualitative interpretations, however; and care must be exercised in making these interpretations because day thermal imagery is influenced by sun angle, terrain slope and elevation, moisture level, and wind conditions. Local variations in these parameters can significantly influence the temperature of a particular surface feature from location to location even within a small area.

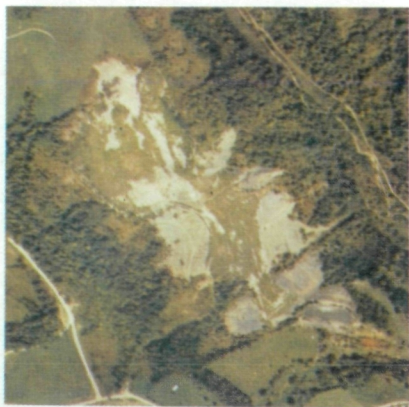
(a) Natural-color aerial photograph.

Figure 22. - Thermal images of subarea 1. Scale factor, approximately 18 000.

The thermal-channel data can also be color coded by a density slice of the data to provide increased contrast, enhanced temperature separation, and improved separation of land-cover features. Parts (c) and (d) of figures 22 and 23 are color-coded thermal images of subareas 1 and 2 and correspond to the scenes in figures 14 and 15. The

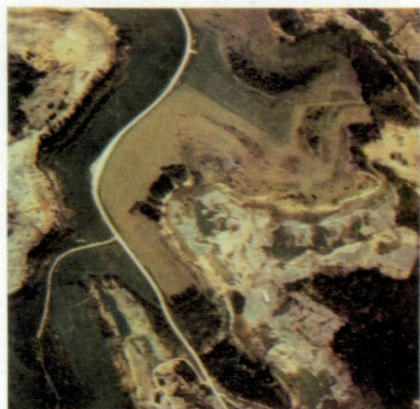
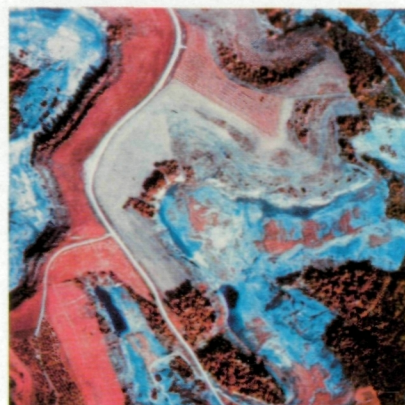
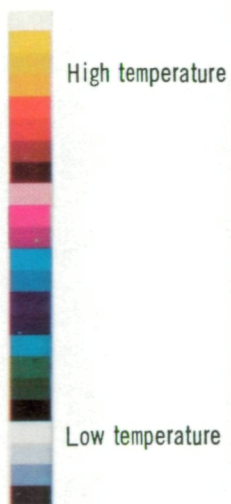
(a) Natural-color aerial photograph.

(b) Color infrared aerial photograph.

(d) Night thermal image.

Figure 23. - Thermal images of subarea 2. Scale factor, approximately 18 000.

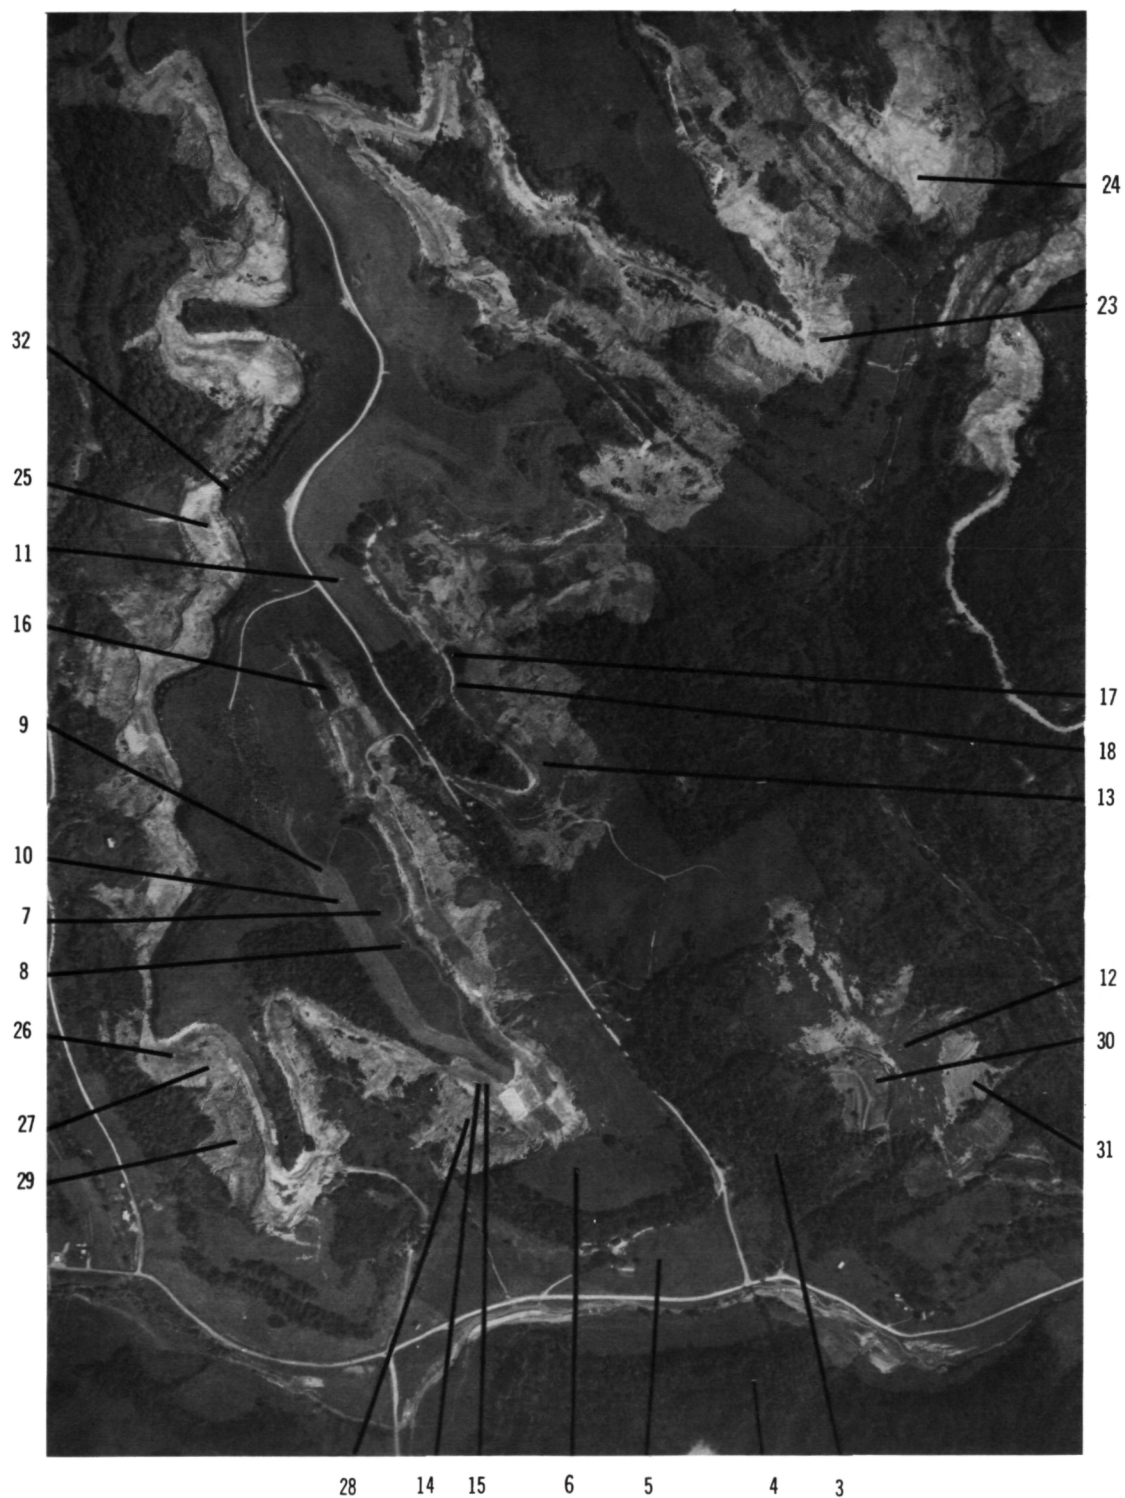
Figure 24. - Training-site locations - September land-cover classification. (Training sites 2 and 19 to 22 are not shown).

The locations of the training sites that were used to make the supervised classification of the strip-mined area's land cover are shown in figure 24. The training sites are described in table V, and the statistical and radiometric data are presented in table VI.

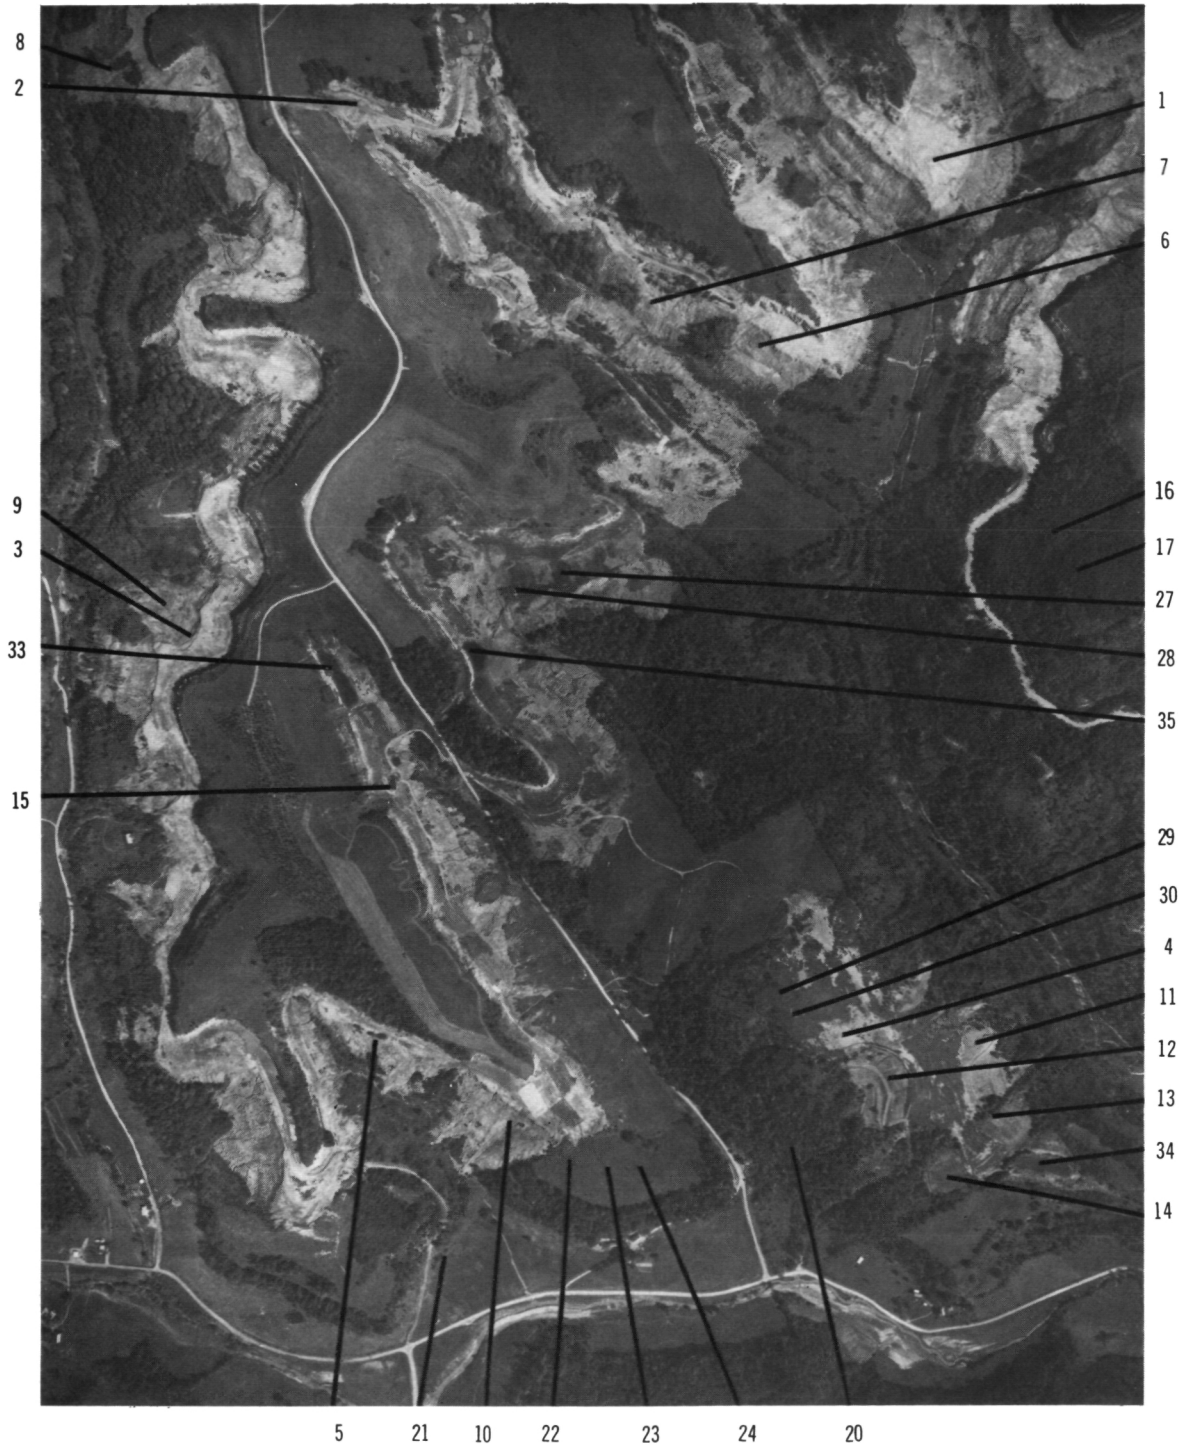
Figure 26. - Training-site locations - March barren-land study. (Training sites 18, 19, 25, 26, 31, and 32 are not included).

The locations of the training sites used for the March barren-land study are shown in figure 26. The training sites are described in table IX, and the statistical and radiometric data are presented in table X.

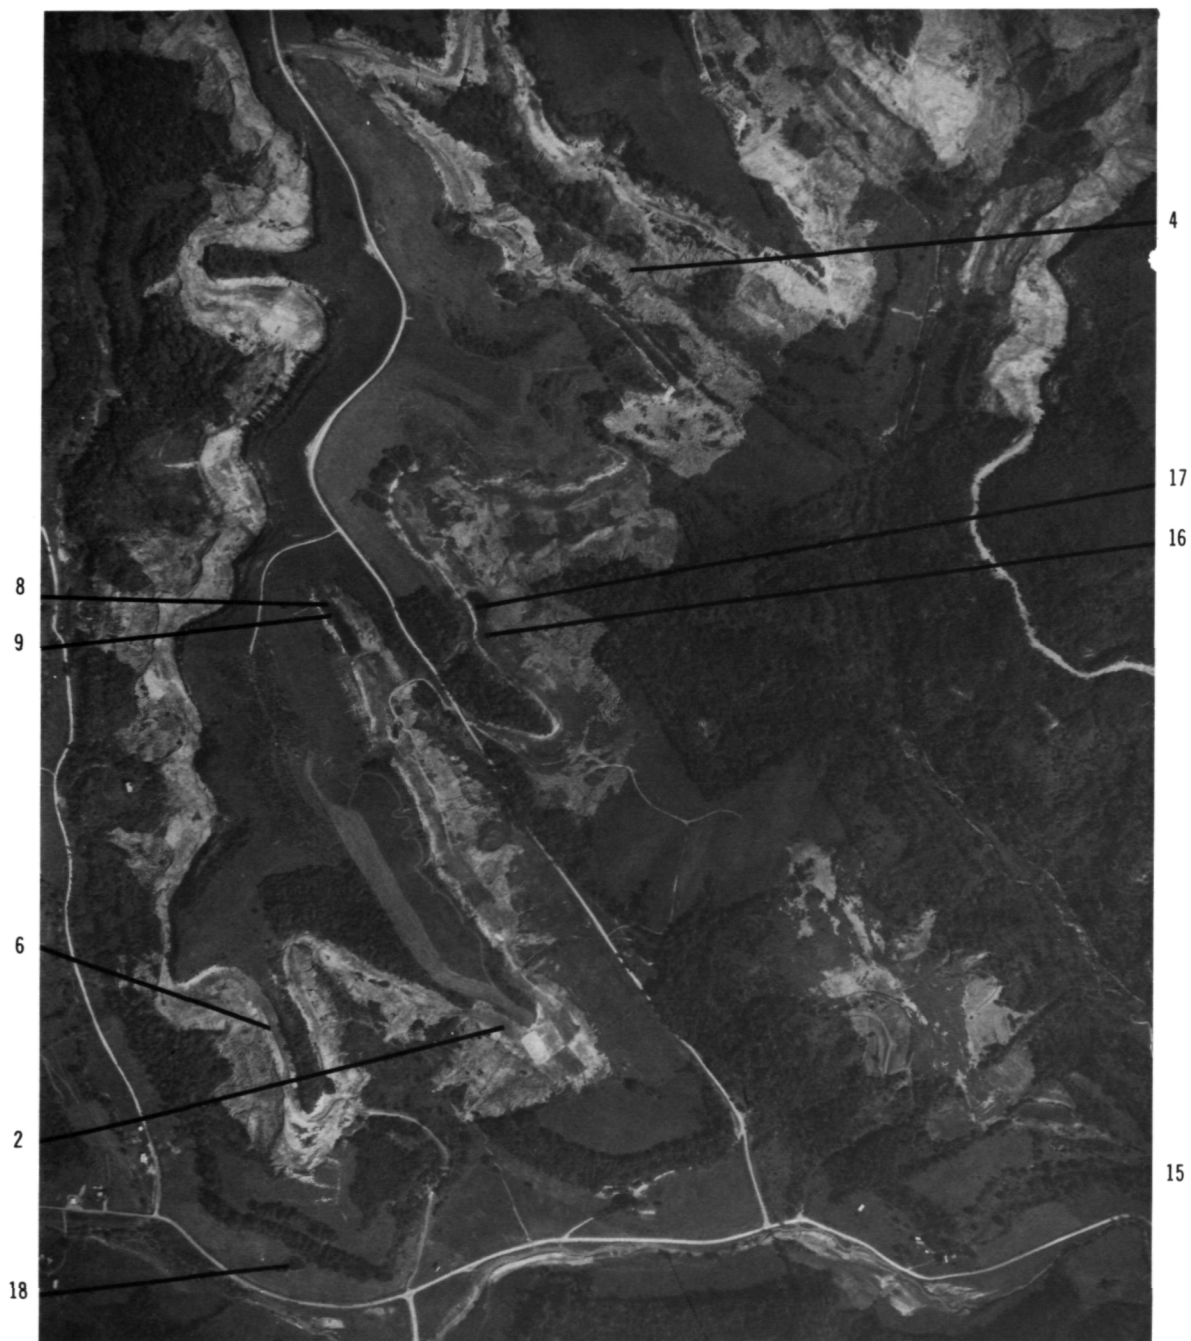
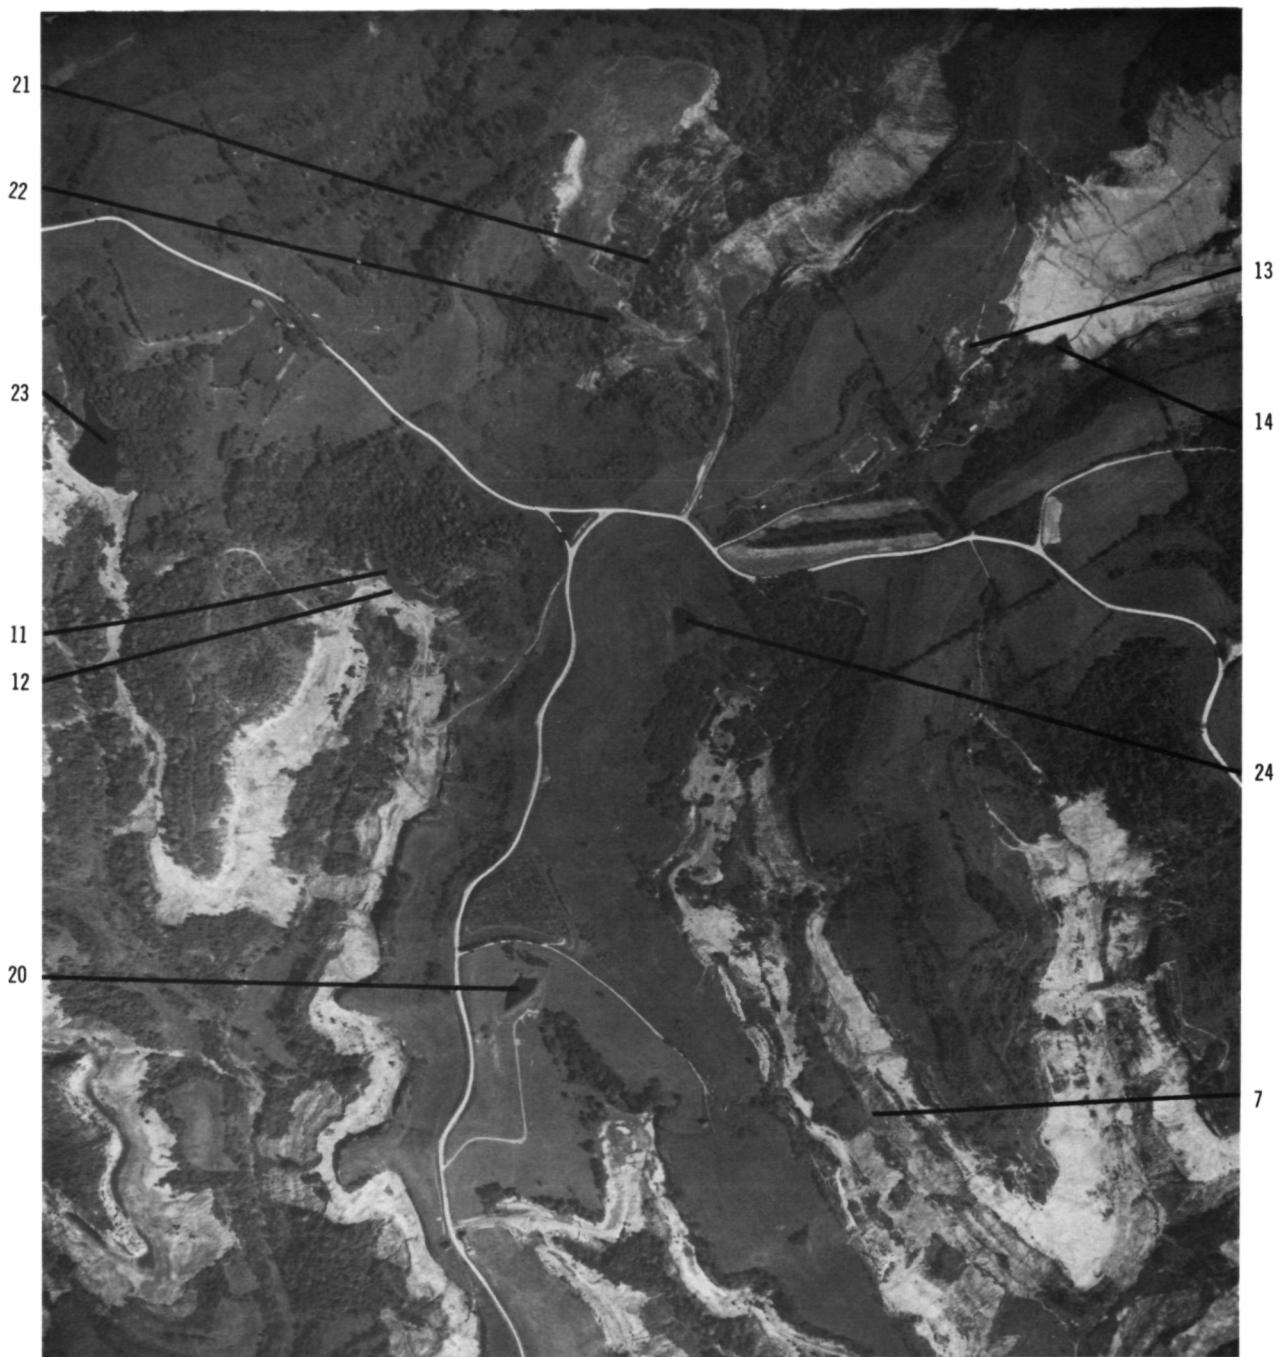
Figure 27. - Training-site locations - September surface-water study. (Training sites 1, 3, 5, 10, and 19 are not included).

Figure 27. - Concluded.

The locations of the training sites used for the September surface-water study are shown in figure 27. The training-site description and the pH and radiometric data are presented in table XI. Radiometric data are presented for scanner channels 3 to 11. The radiometric data for the water test sites are tight statistical clusters, as indicated by the small standard deviation and high eigenvalues. For the water areas, the shorter wavelength channels (3 and 4) become important, but the near-infrared channels (8 to 10) are not as useful as they were for the land-cover classes.
